- Asbestos Demolition/Refurbishment Survey –

External Works

Cerne Abbas

Date: 23rd August 2017

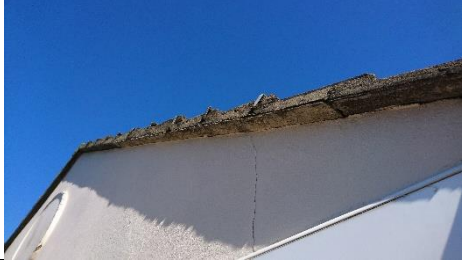
Area & Ref #	Material Description, Location & Amount	Asbestos Type Amosite Chrysotile Crocidolite	Sample n ^o / Visual Identification	Recommendation Mark and Manage Encapsulate Remove	Photograph
E01 Ref 1	No Access to Sample of Undercloaking, 30LM. All Gable end of Buildings.			Exercise Caution

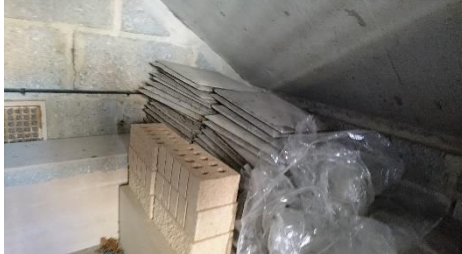
E01 Ref 2	Asbestos Cement Stored Tiles, Tiles are in External Store at Number 11, 15M2.	CHRYBOTILE	001	Remove

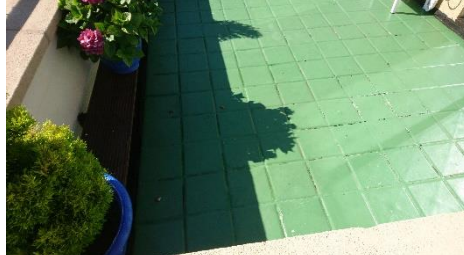
Area & Ref #	Material Description, Location & Amount	Asbestos Type Amosite Chrysotile Crocidolite	Sample n ^o / Visual Identification	Recommendation Mark and Manage Encapsulate Remove	Photograph
E01 Ref 4	Asbestos Cement Floor Tiles, to Some Balconies Unable to Access all Balconies.	Chrysotile	VS 001	Exercise Caution

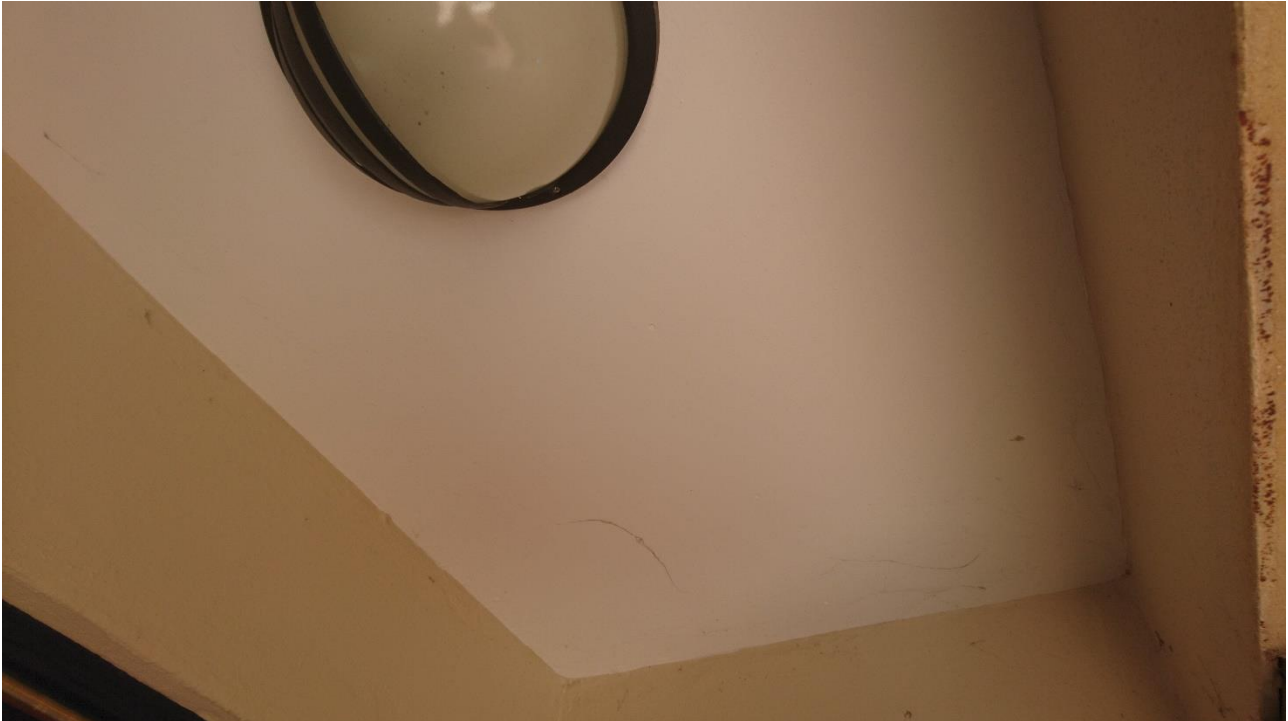
NEGATIVE REFERENCE

Description	Insulation Board Panels
Location	E01 Externals
Sample Reference	002
Reference	Ref 3
Sample Results	NADIS
