Tree Hazard Assessment Report

15 March 2023

Cerne Abbas  
46 The Avenue  
Poole  
Dorset  
BH13 6HF

TS/64723/SC

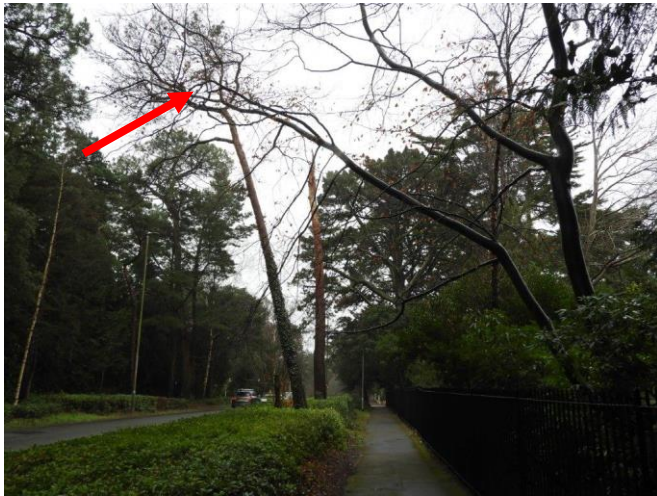
T10, beech. Branch to be pruned is arrowed.

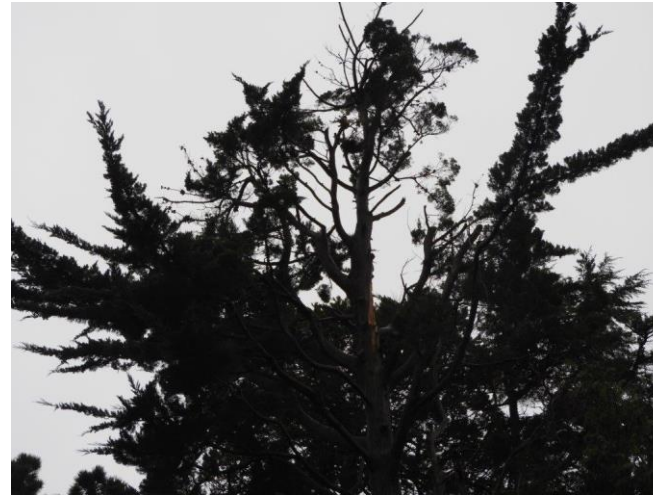
22	Monterey cypress	Early mature	Large wound on upper stem. Tree recently pruned above this point. Some dieback visible and little regrowth from pruning cuts. Wound does not appear to have deteriorated.	The foliage around the recent pruning wounds appears to be dying back in some parts. The wound does not appear to be deteriorating. The die back may need further pruning if it continues, but no work needed at present.	Monitor	-
23	Deodar	Early mature	Low primary branch 3m above drive.	Low branches over driveway may obscure visibility or obstruct vehicles.	Prune low branch back to remove low sub branches. Retain sub branches just proximal to 90 degree elbow.	Moderate 1
25	Western red cedar	Semi mature	Low branches overhang drive near entrance at 2m above ground level.	Low branches over driveway may obscure visibility or obstruct vehicles.	Prune lower secondary branches to give a clearance of 4m over driveway.	Moderate 2

T22, Monterey cypress.

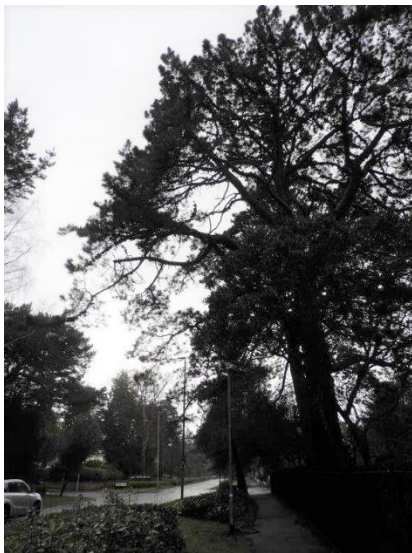
26	Monterey pine	Mature	Large diameter deadwood in crown over path and road.	The dead branches could fall and cause damage or injury to site users or passers-by.	Remove deadwood of diameter greater than 50mm and over 1m in length.	Moderate 1
28	Monterey pine	Mature	Small diameter deadwood in crown.	If T26 is treated, it is reasonable to carry out the same work to T28, although less deadwood was noted.	Remove deadwood of diameter greater than 50mm and over 1m in length.	Moderate 2

T26, Monterey pine

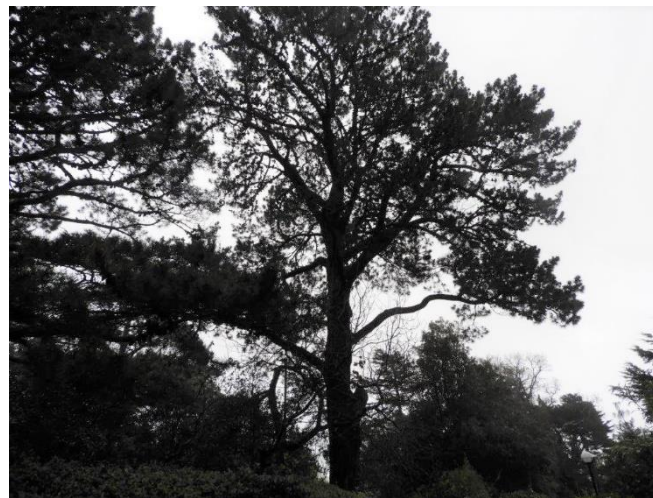
T28, Monterey pine.

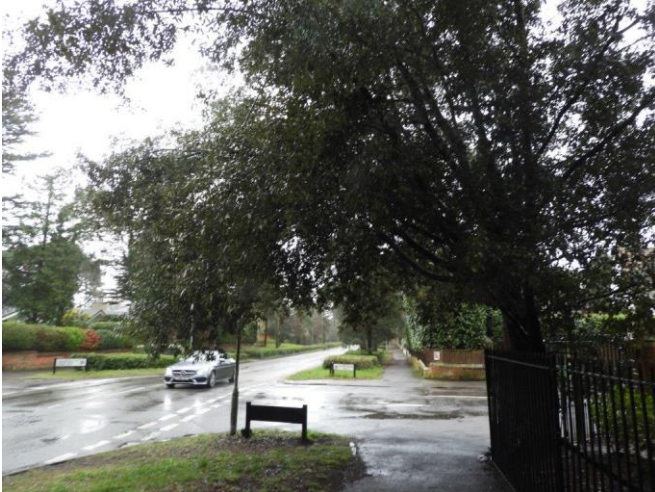
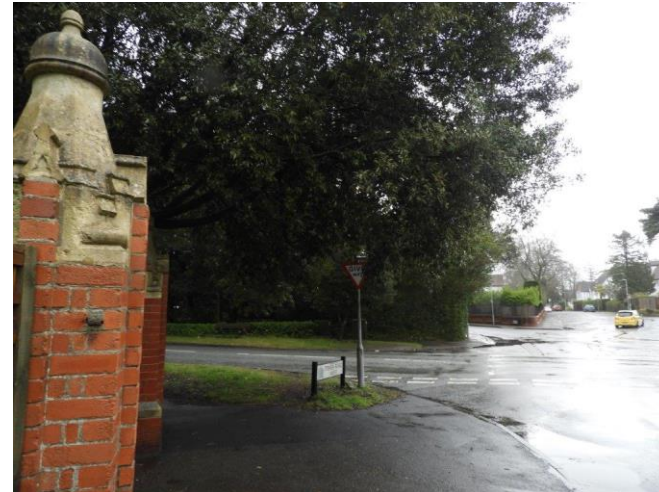
Tree No.	Species	Life stage	Observations	Appraisal	Recommendations	Work priority
133	Lime	Early mature	Low branches over the entrance.	Low branches over entrance may obstruct vehicles.	Prune lower secondary branches to give a clearance of 4m over driveway.	Moderate 2
141	Holm oak	Early mature	At corner of site (Junction of The Avenue and Tower Rd West). Crown 2m above footpath and obscuring give way sign.	Low branches over road may obscure visibility of the sign or obstruct vehicles or pedestrians.	Prune lower secondary branches to give a clearance of 2.3m above the footpath and 5.2m above the road.	Moderate 1
148	Beech	Early mature	In western square. Low branches to 2m above ground level, without foliage. There is lawn and shrubs beneath the tree and patios and rear windows near the crown tip.	Minor pruning and a general crown lift to give 3m clearance above the garden in summer will be beneficial for residents, maintenance staff and the plants growing beneath the tree. This work, if BS3998 is followed, won't affect the health of the tree and is not visible from any public place as it is only to low branches. There is, therefore, no impact on public amenity from this work.	Prune lower secondary branches to give a clearance of 3m in summer and prune back one low primary limb by 2m.	Moderate 2

T141, holm oak

T141, Junction of Tower Rd West and The Avenue.

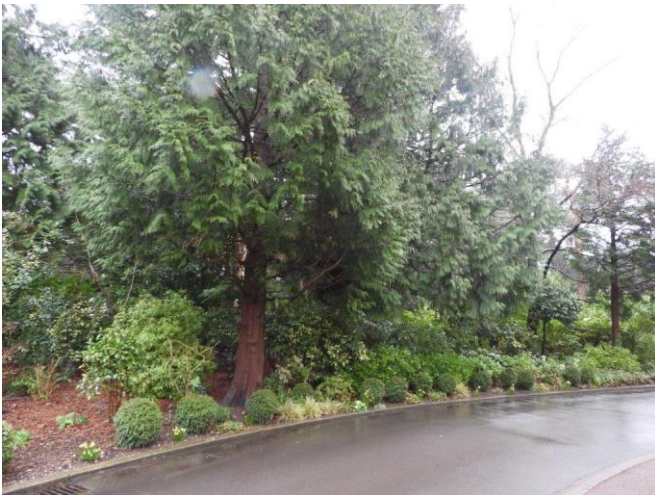
Tree No.	Species	Life stage	Observations	Appraisal	Recommendations	Work priority
6	Western red cedar	Early mature	Low branches overhang drive near entrance at 2m above ground level.	Low branches over driveway may obscure visibility or obstruct vehicles.	Prune lower secondary branches to give a clearance of 4m over driveway.	Moderate 1
11	Beech	Semi mature	Overhangs footpath and road edge. Subdominant stem extends farthest and is becoming codominant.	The subdominant stem could reduce the dominance of the existing main stem. It is better to maintain a single dominant stem by pruning back the subdominant one by 2m to slow its growth rate.	Prune back subdominant stem by 2m.	Moderate 2
19	Strawberry tree	Early mature	Low branches overhang drive at 3m above ground level.	Low branches over driveway may obscure visibility or obstruct vehicles.	Prune lower secondary branches to give a clearance of 4m over driveway.	Moderate 2

T6, western red cedar

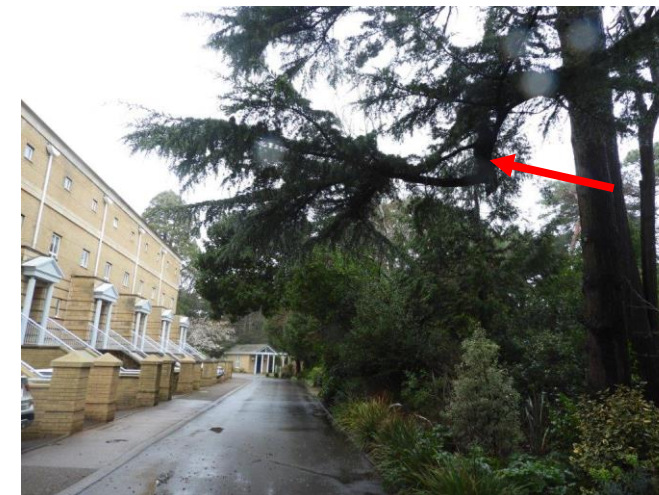
T23, Cedar. The red arrow shows the recommended pruning point.

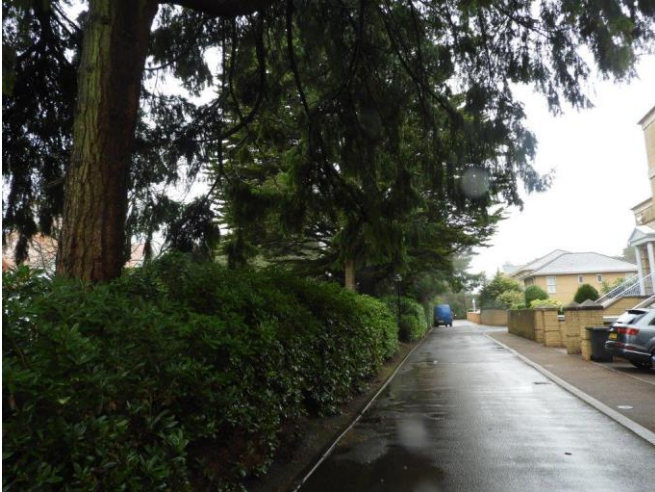
Tree No.	Species	Life stage	Observations	Appraisal	Recommendations	Work priority
41, 42, 45, 48, 50, 54g, 56, 57, 61	Beech, Douglas fir, Monterey cypress, beech, Douglas fir, deodar, arb, Scots pine.	Early mature	Low branches over Tower Road West.	Low branches over road may obscure visibility or obstruct vehicles.	Prune lower secondary branches to give a clearance of 2.3m above the footpath and 5.2m above the road.	Moderate 1
67, 73, 87, 89, 80, 92, 96, 83	Norway maple, holm oak, 2 Scots pines, cedar, 2 Monterey cypresses, Monterey pine.	Early mature	Low branches over Forest Road	Low branches over road may obscure visibility or obstruct vehicles.	Prune lower secondary branches to give a clearance of 2.3m above the footpath and 5.2m above the road.	Moderate 1

T42, Douglas fir.

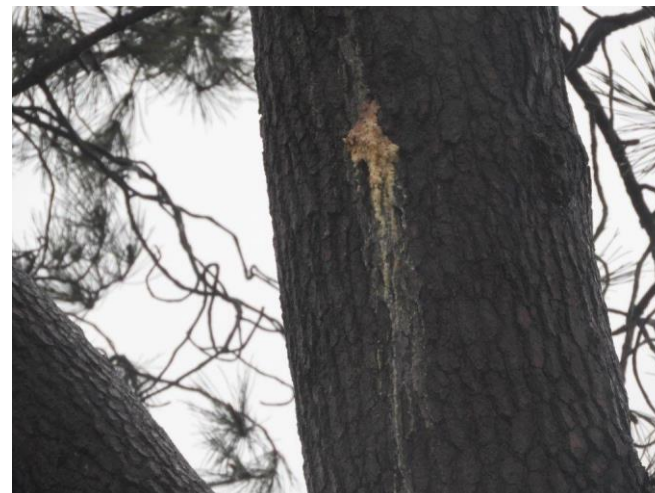
T58. Close up of exudate.

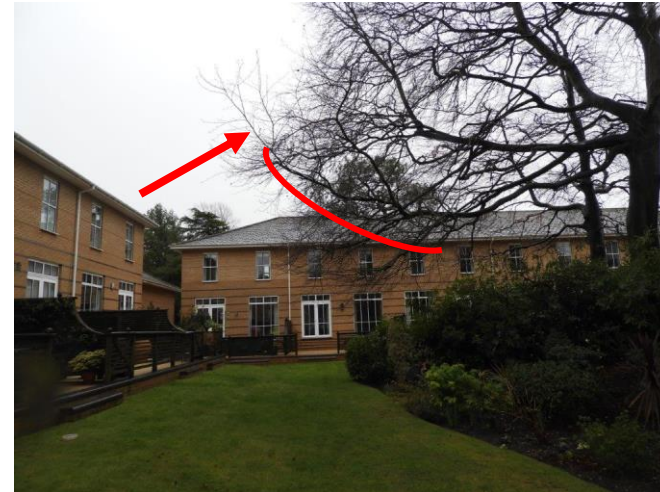
149	Beech	Early mature	In western square. Low branches to 2m above ground level, without foliage. One low primary limb extends far over lawn towards patio. Minor pruning to low primary limb will not affect the tree and a general crown lift to give 3m clearance above ground in summer will be beneficial for residents, maintenance staff and the plants growing beneath the tree.	Minor pruning, including pruning back one low branch by approx. 2m and a general crown lift to give 3m clearance above the garden in summer will be beneficial for residents, maintenance staff and the plants growing beneath the tree. This work, if BS3998 is followed, won't affect the health of the tree and is not visible from any public place as it is only to low branches. There is, therefore, no impact on public amenity from this work.	Prune lower secondary branches to give a clearance of 3m in summer and prune back one low primary limb by 2m. Ref BS3998, work won't affect health of tree and is not visible from any public place.	Moderate 2

T149, beech. Long branch arrowed.  
Pruning line of lowest primary branch shown.

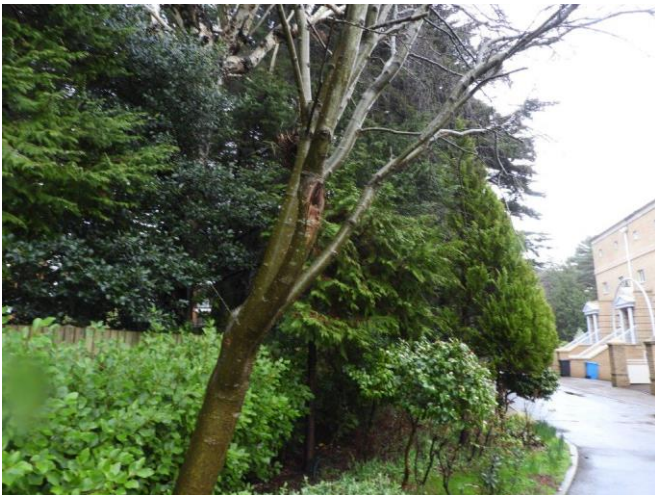
121	Laburnum	Early mature	At edge of drive, opposite No 53. Damage primary branch overhanging drive.	The damaged branch could suffer more damage from vehicles or damage them as they pass.	Remove damaged branch.	Moderate 2
Unnumbered	Monterey cypress	Early mature	On adjacent land at Evesham Court. No access to base. Low small primary branch droops low over shrubs and lamp column. Close to trees T121 and T122.	The drooping branch is affecting the growth of shrubs beneath and is too close to the lamp column, affecting its function. Removal of the branch will not affect the health or public amenity value of the tree.	Remove drooping branch.	Moderate 2
123	Western red cedar	Early mature	Low primary branch split near stem. Distal part pruned.	The recent pruning appears to have taken pressure off the branch. It may deteriorate over time, but no work is needed at present.	Monitor	-
125-127	Western red cedar, bay	Early mature	Low branches to 3m over drive.	Low branches over driveway may obscure visibility or obstruct vehicles.	Prune lower secondary branches to give a clearance of 4m over driveway.	Moderate 2

T121, laburnum.

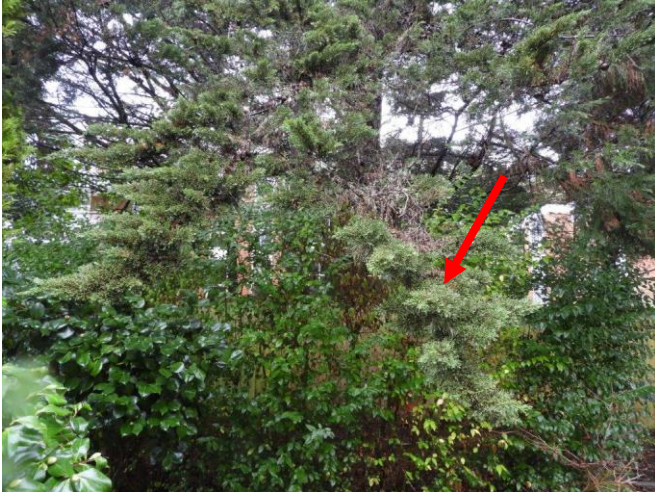
Monterey cypress at Evesham Court.

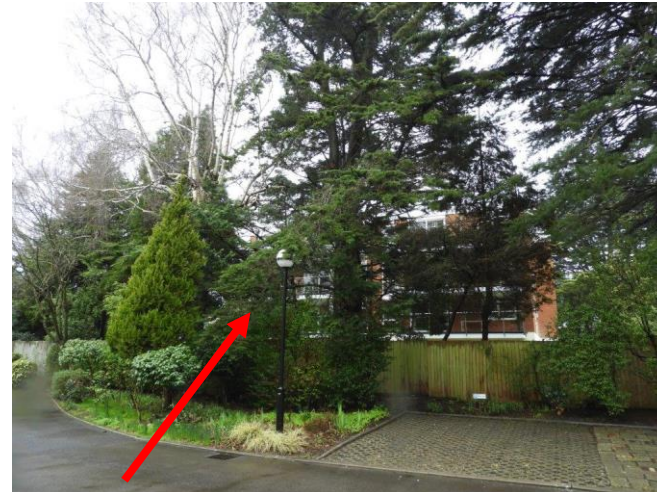
Monterey cypress. Drooping branch arrowed.

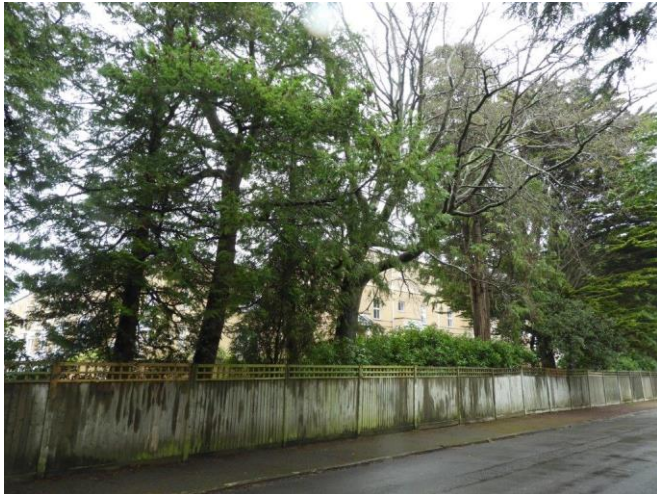
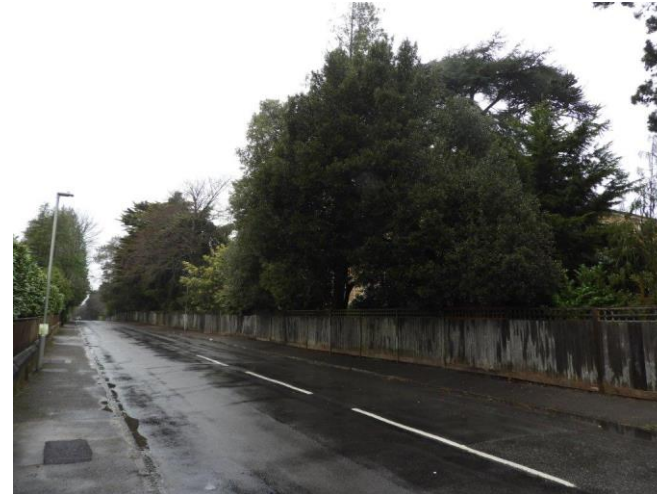
Tower Rd West, overhanging branches.

Tower Rd West.

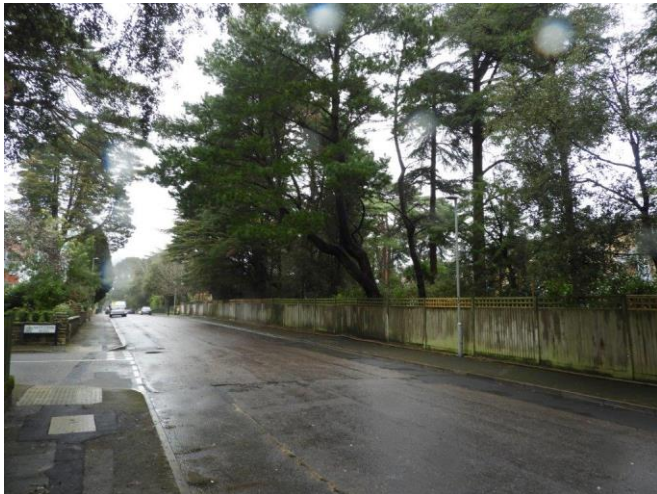
Forest Rd, overhanging branches.

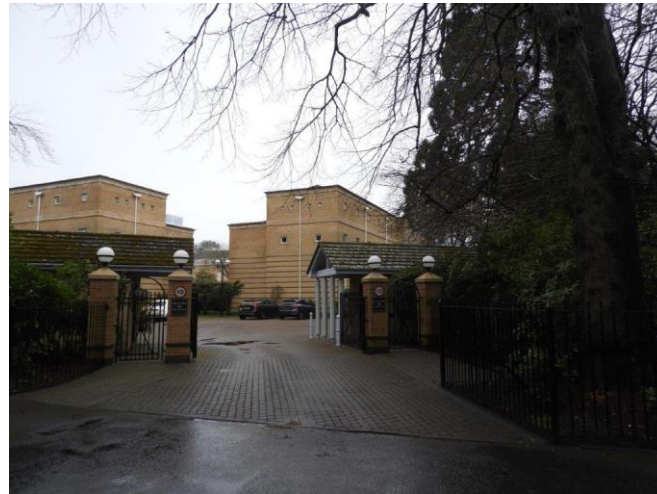
T133, lime. Low branches over entrance.
