- Asbestos Demolition/Refurbishment Survey –

External Works

Cerne Abbas

Date: 23rd August 2017

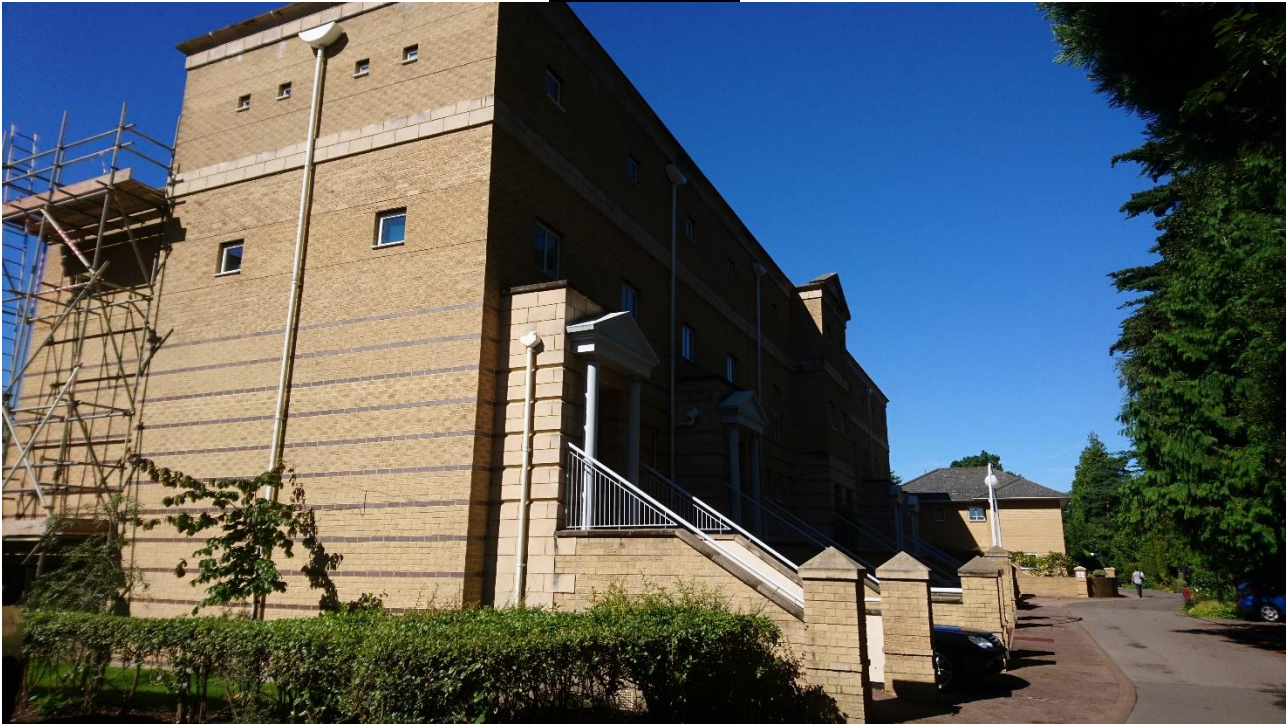
PHOTO PLATE 1

Description	LOCATION PHOTOGRAPH
Project Title:	Cerne Abbas
Date Surveyed:	10 th August 2017
Location:	Front
